Condition Assessment & Master Planning Final Report

DEPARTMENT
OF
DEVELOPMENTAL
SERVICES

VOLUME 6.3
INFRASTRUCTURE STUDY - LANTERMAN

Volume 6.3 - Lanterman Infrastructure Study

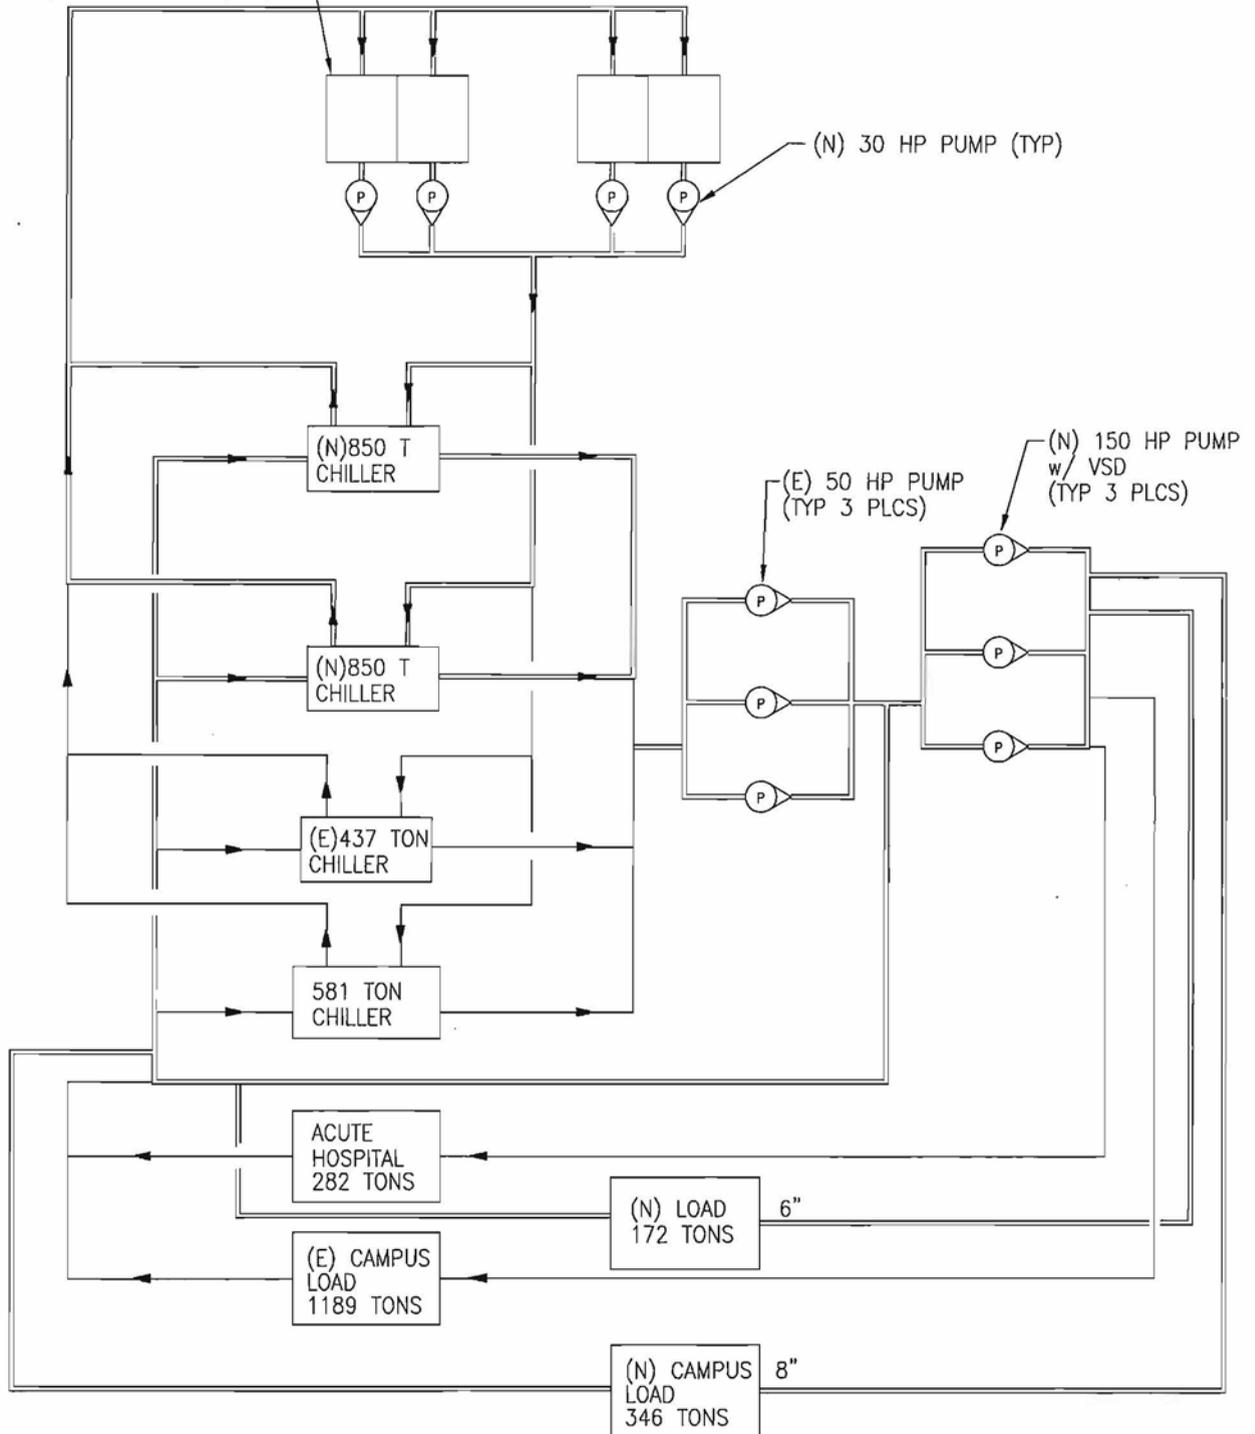
LANTERMAN DEVELOPMENTAL CENTER PROPOSED MECHANICAL CONDITION

(N) 2-CELL 900 TON COOLING TOWER w/ VSD ON FAN (TYP)

Replace two existing, 437 ton chillers with two, 850 ton, 2-stage absorption chillers. This would provide adequate cooling for the full build-out and adequate back-up. The two new chillers should fit in the existing space vacated by the two 431 ton chillers. The 850 ton absorption chillers would be operated as the base-load units. Make the existing pumps into primary circulating pumps. Provide new pumps (three @ 150 hp, each) to act as secondary loop pumps. The secondary loop pumps would be fitted with variable-frequency drives (VSD's). Replace the existing cooling towers with two new, 900 ton towers with VSD's on the fans. Replace the condenser water pumps with four new pumps @ 30 HP each.
